I-40 Pigeon Gorge North Carolina Existing NCDOT Bridges Field Review August 28th, 2019

1.0 INTRODUCTION

2.0 BRIDGE REPLACEMENT FIELD REVIEW

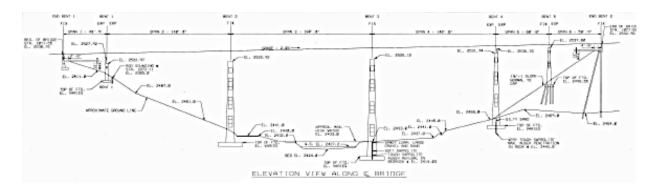
Existing Bridge

The bridge is a total of 610 feet in length and sits about 90 feet above the valley floor it traverses. It comprises six spans of varying length sitting on five piers of varying height. From below the piers look in reasonable condition but the bridge girders and deck appear to be in poor condition. Given the sounds from above, the expansion joints/plates are loose and are creating loud noise when traffic passes over them that would be a deterrent to wildlife. Abutment slopes on each end are steep and essentially absent of vegetation. A low volume two lane road and small creek flow in a u-shaped valley beneath the structure. The adjacent lands and riparian area of the creek are well vegetated. Apart from the noise, the existing bridge and its configuration would appear to function well as a means for wildlife to cross beneath the I-40.

An overall replacement of the bridge with new robust expansion joints should eliminate much of the noise currently generated by the structure. It will remain very open and conducive to wildlife movement. Care will need to be taken to reduce overall footprint of disturbance and clearing to a minimum and rehabilitation and replanting should be included in the project. Thought should be given in specifying ways and means of not inhibiting wildlife movement under the structure during construction.

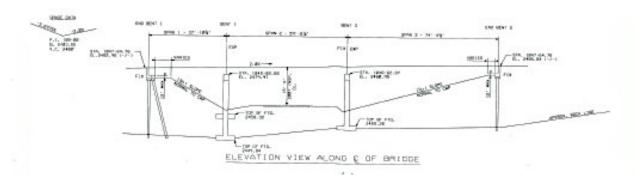
Existing Bridge

The bridge is a total of 172 feet in length and has a vertical clearance of about 15 feet above a low volume, two-lane road it traverses. It comprises three spans of varying length sitting on two piers of similar height. From below, the piers look in reasonable condition but the bridge girders and deck appear to be in poor condition. Abutment slopes on each end are moderately steep and absent of vegetation. Given the sounds from above, the expansion joints/plates are loose and are creating loud noise when traffic passes over them that would be a deterrent to wildlife. Apart from the noise, the existing bridge and its configuration is open and likely functions adequately as a means for wildlife to cross beneath the I-40. There exists a narrow 8 foot, grassed shoulder on both sides of the roadway beneath the structure that may support wildlife movement. There is certainly the possibility of a conflict between vehicles and large mammals using the roadway.

Both proposed replacement structures will significantly reduce the overall openness of the bridge from its current length of around 170 feet to a width of between 47 and 67 feet, essentially just spanning the existing two-lane road. Studies and experience have shown that elk are hesitant about passing through box culvert structures, especially when they are dual purpose i.e. functioning as a road as well as wildlife passage. Although White Oak Road appears to a relatively low volume roadway, the probability of this structure functioning as an effective wildlife crossing based on the proposed replacement designs as discussed in the field with NCDOT and its consultant Benesch is low.

Ideally from a wildlife perspective, the replacement structure should maintain the current overall width, construct vertical abutment walls thus avoiding the sloping sides and either span the distance without any piers or maintain the three span design. This would create 30 and 50 foot wide movement corridors on either side of the road for wildlife. It is acknowledged that this would be more expensive than the box culvert style design being proposed. Alternatively, the shorter 30 foot span could be eliminated and only the 50 foot corridor maintained.

A compromise might be to install 8 ft diameter corrugated steel plate culvert or equivalent sized precast concrete box culverts on one or both sides of the proposed new structures where the existing slopes are currently prior to these areas being backfilled. While these will not be used by elk, smaller animals such as deer and black bear are known to use these more confined types of crossing structure.

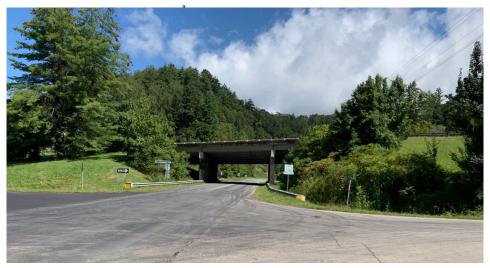
Existing Bridge

The bridge is a total of 164 feet in length and has a vertical clearance of about 15 feet above a busy two-lane road that serves as access to an area landfill. It comprises three spans of varying length sitting on two piers of similar height. From below, the piers look in poor condition as do the bridge girders and deck. Abutment slopes on each end are steep and absent of vegetation. Given the sounds from above, the expansion joints/plates are loose and are creating loud noise when traffic passes over them that would be a deterrent to wildlife. There exists a narrow 10 foot, grassed shoulder on both sides of the roadway beneath the structure that may support wildlife movement. Apart from the noise from both traffic above and that passing through the structure, the existing bridge and its configuration is open and could functions as a means for wildlife to cross beneath the I-40. There is certainly the possibility of a conflict between vehicles and large mammals using the roadway. Further possibly reducing use by wildlife is the proximity of the Pigeon River and the need to traverse the river or use a narrow highway bridge.

Both proposed replacement structures will significantly reduce the overall openness of the bridge to a width of less than 40 feet essentially matching the existing two-lane road. Studies and experience have shown that elk are hesitant about passing through box culvert structures, especially when they are dual purpose i.e. functioning as a road as well as wildlife passage. The Fines Creek Road appears to carry a large number of trucks accessing the nearby landfill creating noise likely early to late in the day. The probability of this structure functioning as an effective wildlife crossing regardless of the proposed replacement designs as discussed in the field with NCDOT and its consultant Benesch is low.

The installation of 8 ft diameter corrugated steel plate culvert or equivalent sized precast concrete box culverts on one or both sides of the proposed new structures where the existing slopes are currently prior to these areas being backfilled. While these will not be used by elk, smaller animals such as deer and black bear are known to use these more confined types of crossing structure.
