Recommendations to mitigate the impacts of Mexico's Federal Highway 2, on the wildlife of the Sky Islands

Main Authors

Biol. Mirna Manteca, Biol. Cecilia Aguilar, C. Juan Carlos Bravo
Wildlands Network

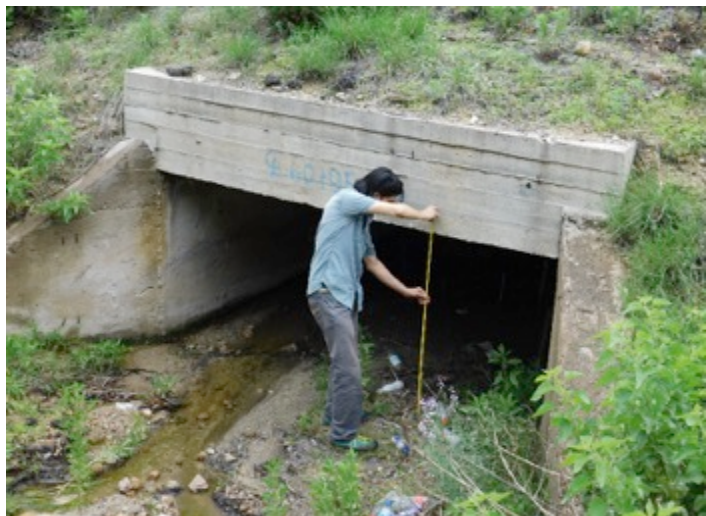
Evaluation of drainages. Photo: EcoGrande

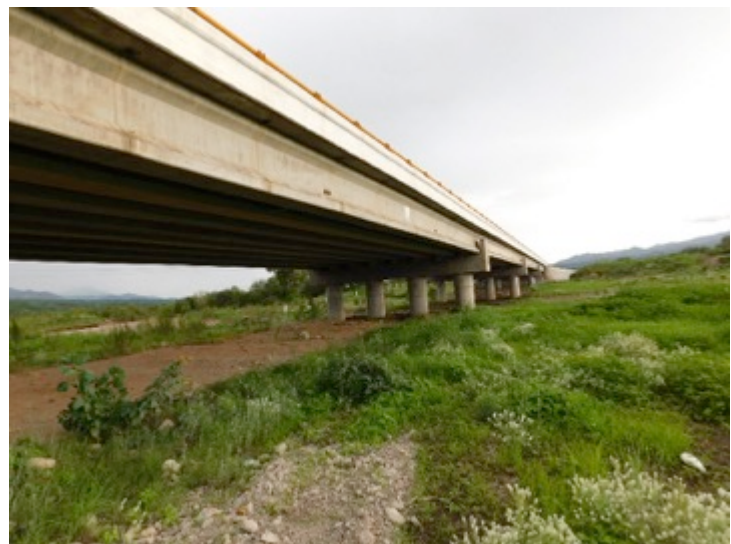
The category of drainages suitable for small wildlife includes structures *San Antonio bridge. Photo: EcoGrande* whose opening area does not exceed 1.2m². If it did exceed this number but their height was less than 1.2 m they were still considered for small animals. The category of drainages suitable for

medium animals includes structures with an opening area between 1.2 m² and 6.30 m². The category of drainages suitable for large animals includes structures with more than 6.30 m².

We also recommend the adaptation of the drainages between km 115 and km 136 (in the following table) for medium and small species such as collared peccaries and coachwhip snakes. The bridges San Antonio, **km 117 (30.973792, -110.582119)**, and Los Alisos, **km 124 (30.922274, -110.610887)**, are large enough to allow free passage of animals. We recommend adapting Los Alisos bridge as a wildlife crossing by adding a curb and including San Antonio bridge within the fenced section.

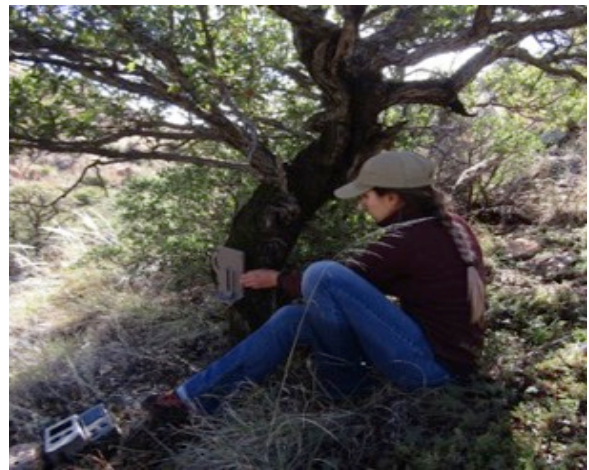
We placed the cameras in trees with screws, safe boxes and locks with metal wire to prevent them from being stolen, however, some drainages did not have nearby trees, so we decided to fix them on their ceilings or walls using a drill, anchors and screws. We changed batteries and memory cards every two months.

Personnel placing camera traps. Photo: Wildlands Network

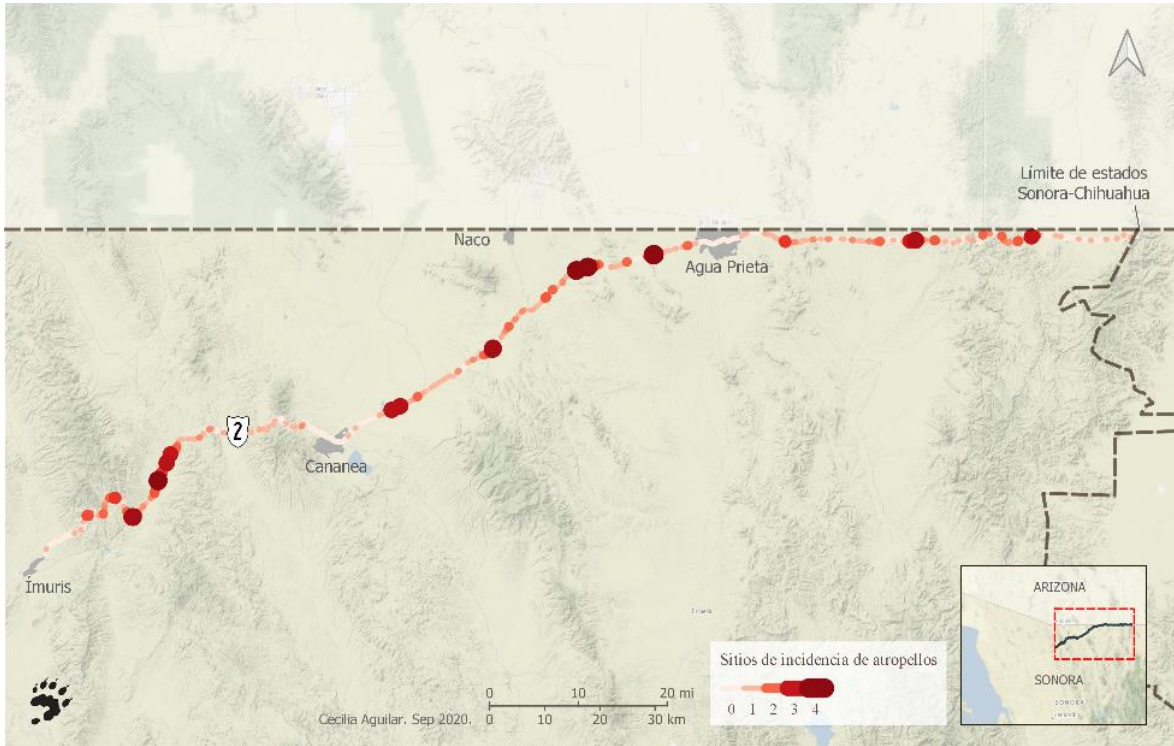
Areas with the highest incidence of roadkill

We were able to identify at least 27 sites that are critically important areas along the Ímuris – Sonora-Chihuahua State Limits section, of which 14 are found in the wildlife corridor Sierra Azul-El Pinito, six in the grasslands between Cananea and Agua Prieta and the remaining seven in the wildlife corridor Sierra Peloncillo. Likewise, we identified 29 sites of medium importance along the entire section. It is worth mentioning that many of these sites are on straight sections of the road where drivers tend to increase speed.

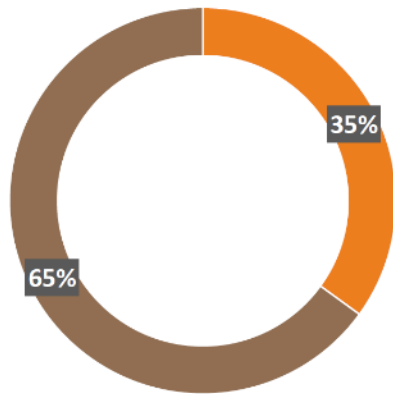
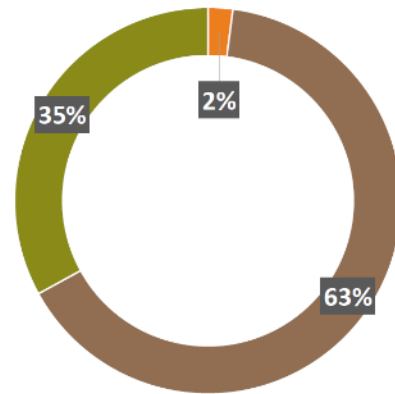
Small drainages add up to 415 (59%); 268 (65%) of these are clogged with garbage, rocks or other items that obstruct the passage. **Only nine (2%) small drainages have high potential of use by small wildlife.** On the other hand, 260 (63%) drainages are of moderate use. We consider that with the proper and constant maintenance they could be used by small sized wildlife. 146 (35%) of small drainages have low or no use potential and require maintenance.

Drenajes Pequeños

Con Problemas de Azolvamiento

Libres Azolvados

Potencial de Uso por Fauna

Uso Alto Uso Moderado Uso Bajo o Nulo

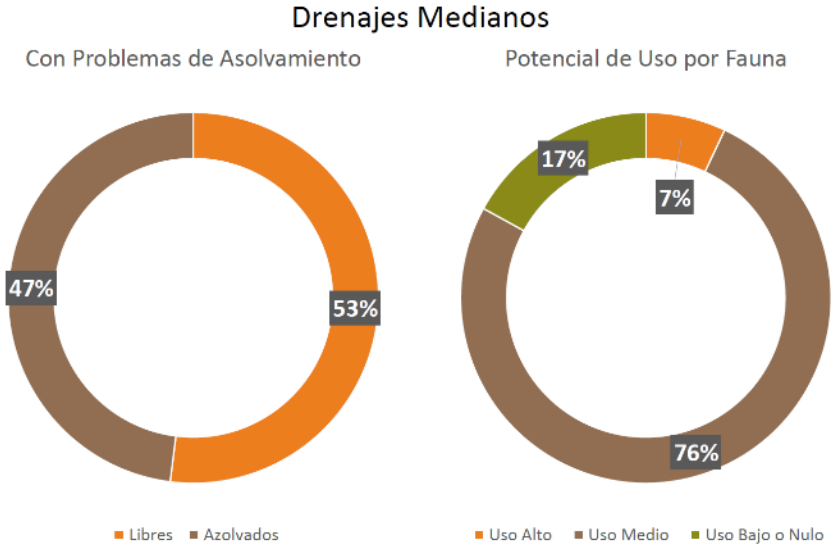
Medium size drainages that are considered of great importance for use by medium and small wildlife add up to 176 (25%). We documented accumulation of sediment problems and other obstructions in 83 (47%) of these. **Of the total medium drainages, 13 (7%) have high potential of use by medium and small wildlife**, 134 (76%) have moderate potential and 29 (17%) have low or no potential of use.

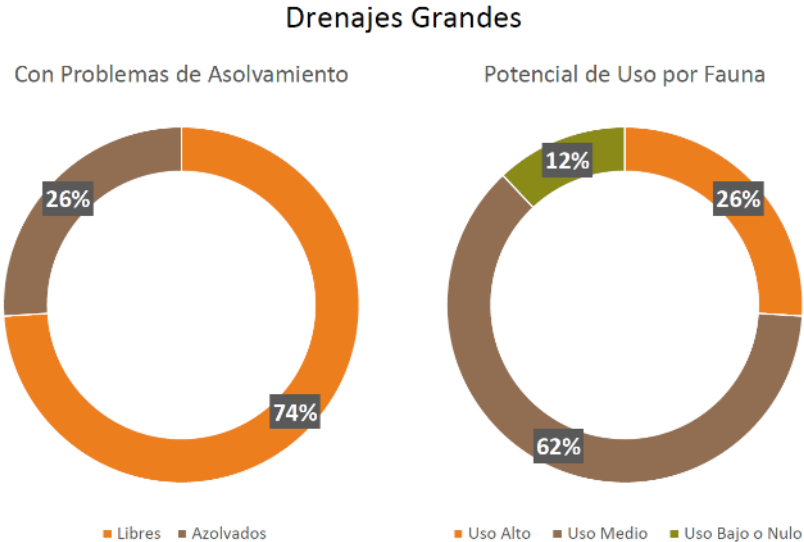
Finally, large category drainages—especially bridges—are considered the most important for wildlife crossings. Of the total of drainages in the section, this kind add up to 89 (12%). 23 (26%) drainages presented elements that hinder their potential use as wildlife crossing. **Another 23 (26%) large drainages or bridges have a high potential**, 55 (62%) have moderate potential of use and 11 (12%) have low or no potential of use.

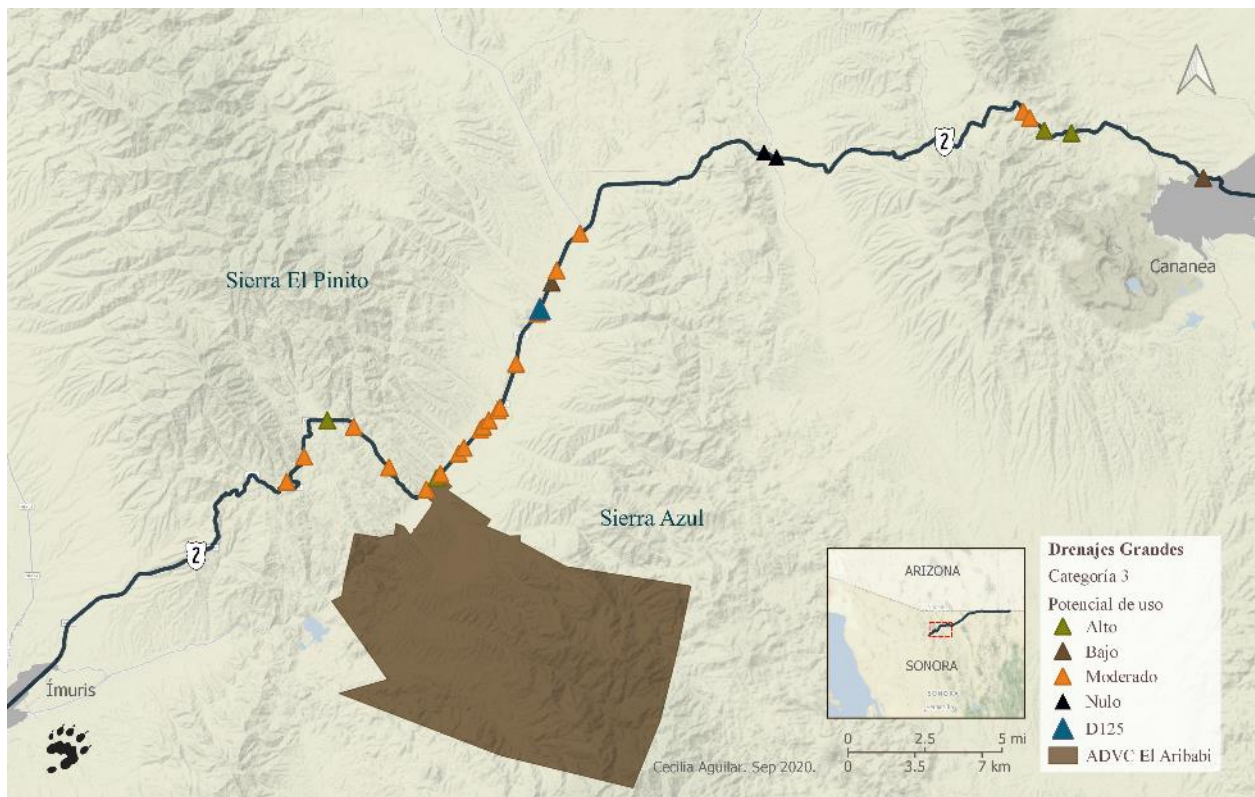
Location of Category 3 (large) Drainages of the Ímuris-Cananea section of Federal Highway 2

It is important to point out that on kilometer 121 + 500 there is a stream for which no drainage was built on the road. The stream appears to be diverting to drainage D125. It is also important to mention that in the D228 drainage a western tiger salamander (*Ambystoma mavortium*) was registered, a species whose populations have suffered an alarming decline in recent decades mainly because of factors related to the modification of its habitat, pollution of rivers and lakes and introduction of invasive exotic species (PACE, 2018). Salamanders are vulnerable species and indicators of a healthy ecosystem. The presence of this species shows us that we still have time to preserve and connect the region's ecosystems for aquatic species. These sites are indicated in the maps below:

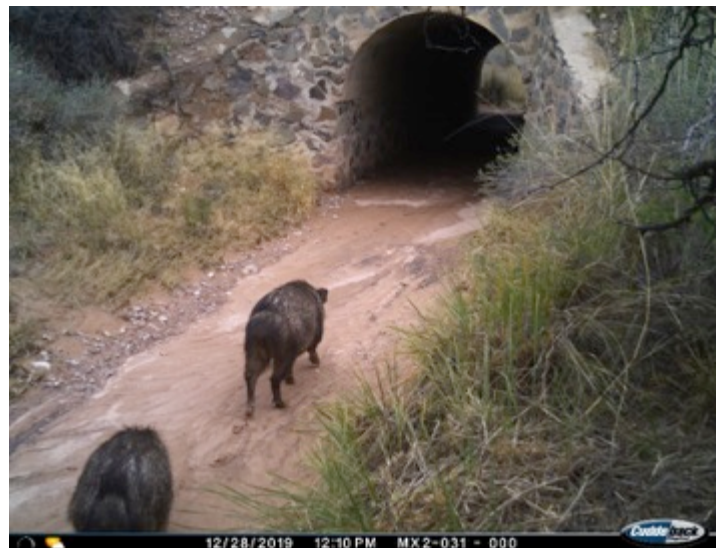
Collared peccaries (Pecari tajacu) using a drainage to cross. Photo: Wildlands Network

We registered a total of 18 species using the drainages at both sites where we placed camera traps, having the Sierra Azul-El Pinito wildlife corridor the greater diversity with 18 species while in Sierra Peloncillo we registered 17 species total. Most of the recorded species were small to medium size except the cougar and white-tailed deer, which were the largest.

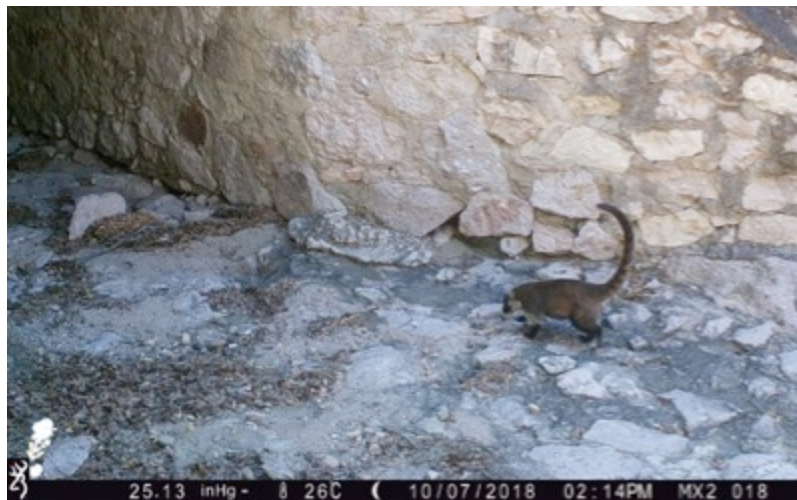
Coati (Nasua narica) using a drainage to cross the road. Photo: Wildlands Network-Sky Island Alliance

Despite this fact, some species—such as coatis—seem to have adapted their behavior to take advantage of drainages and bridges as wildlife crossings. Others, like black bears, show no signs of having adapted.

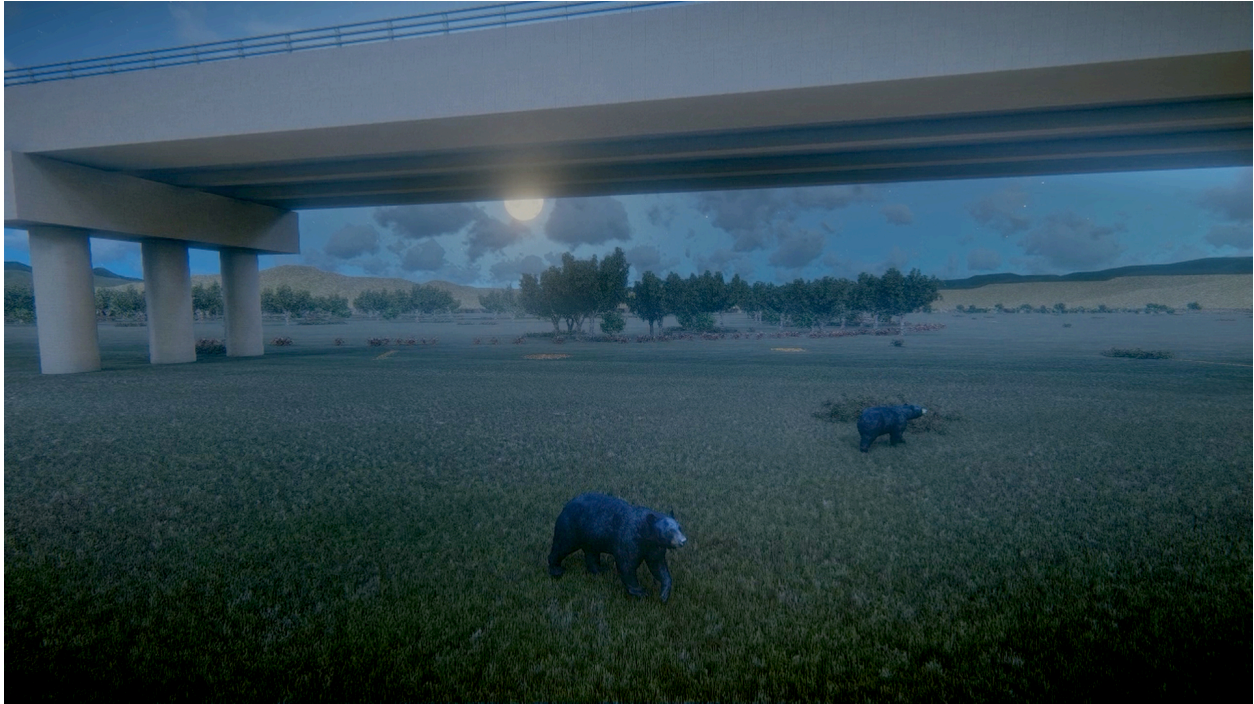
3D model of the viaduct in the possible future highway bypass in the ADVC Rancho El Aribabi. Illustration: P. Capdevielle, S. De la Rosa and Jacalito Films

In the case of the future highway bypass project in Ímuris, it is essential to emphasize that the road should not be built over the Cocóspera River. The infrastructure design of the current line must incorporate a viaduct over the area where remains of a *ciénega* (wetland ecosystem) are identified within the ADVC Rancho El Aribabi. An elevated viaduct will not only function as wildlife crossing but will also allow the restoration of this wetland, which can be a compensation component of the highway project itself.

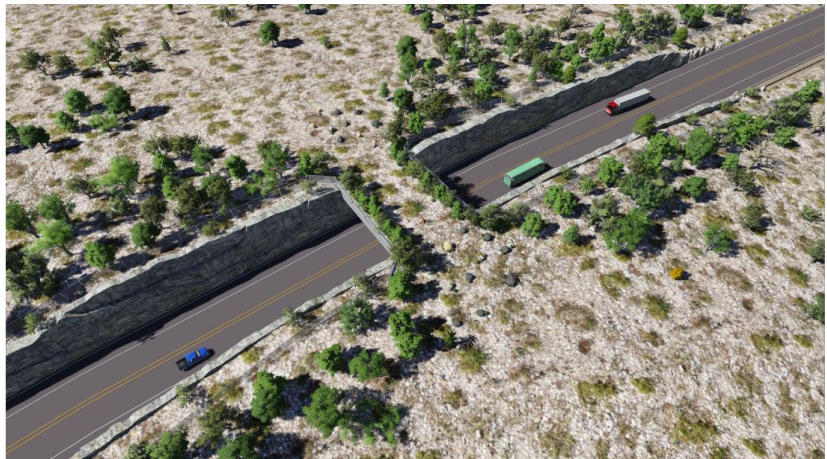
3D model of the possible wildlife crossing in the Sierra Peloncillo wildlife corridor. Source: Pedro Capdevielle

The number and proximity of hotspots and drainages that can be used as wildlife crossings in the identified area is such that we recommend building a single 20-kilometer long wildlife corridor that goes from **kilometer 93 to kilometer 113** to avoid leaving open sections that could reduce its effectiveness.

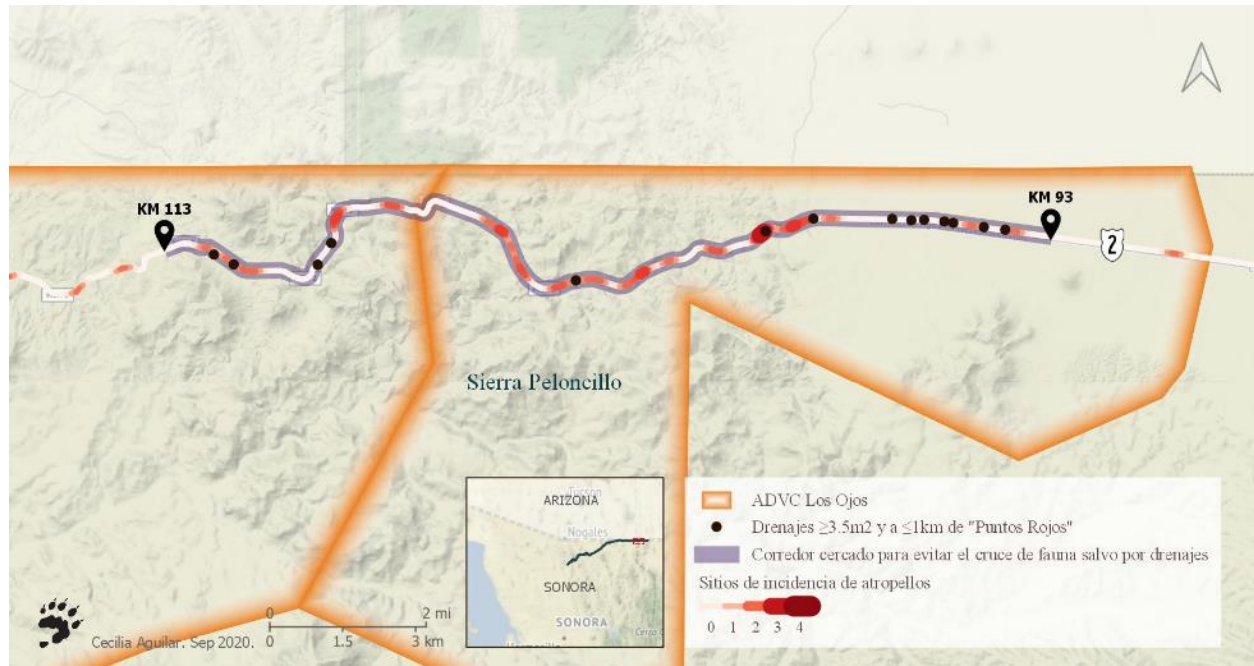
Corridor location for the safe crossing of wildlife

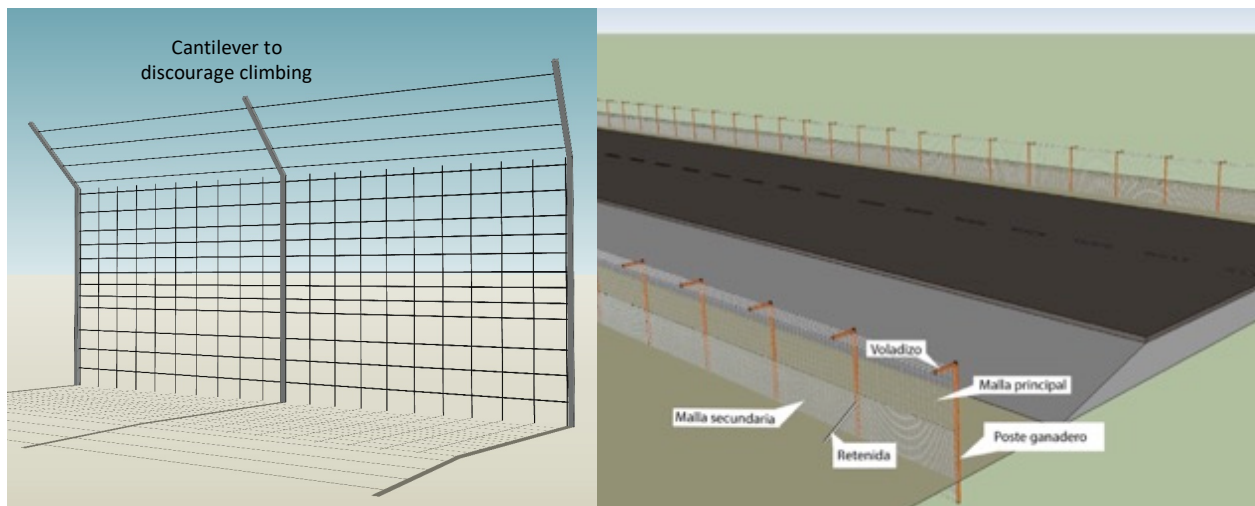
Recommended for use is a 10-foot cattle pole every three meters with steel cables every 50 meters. A 45° metal angle will be placed at the top of each pole to form the cantilever.

An overhang using barbed wire will be placed projecting from the top of the fence, at about 45° and facing away from the road to prevent animals such as bears and felines from climbing the fence and reaching the pavement.

Components of inductive fences. Illustrations: Pedro Capdevielle and Juan Carlos Bravo

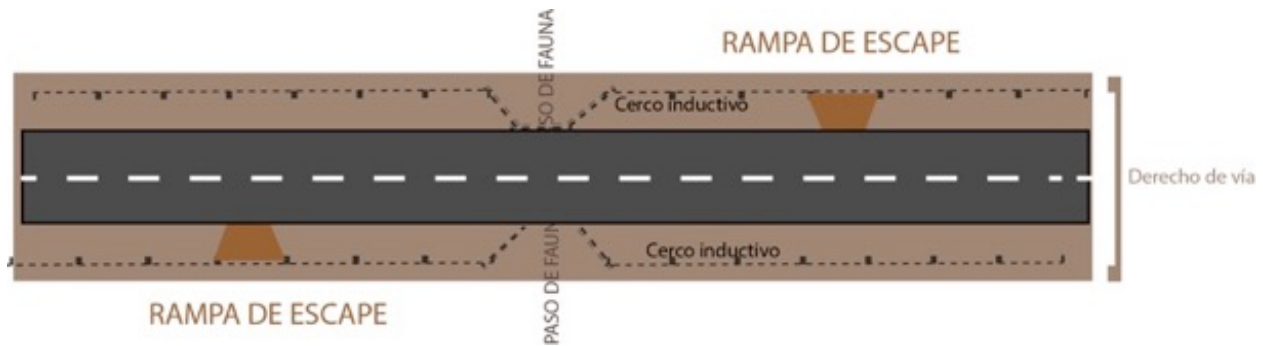
We recommend building escape ramps at a distance no longer than 2 kilometers between each other, alternated on each side of the road.

Location of escape ramps. Illustration: Juan Carlos Bravo
